Monroe County Soil and Water Conservation District

This letter is in regards to the site visit made to the stormwater pond located on the corner of Paul Road and White Oak Bend in the Town of Chili. Staff from Monroe County Soil and Water Conservation District and Monroe County visited the pond site on Tuesday June 7th, 2016 to address concerns about whether or not the pond requires dredging. After careful site evaluation, I do not believe that the pond needs to be dredged at this time. Instead, I have listed some suggestions below that may help improve the aesthetics and functionality of the stormwater pond.

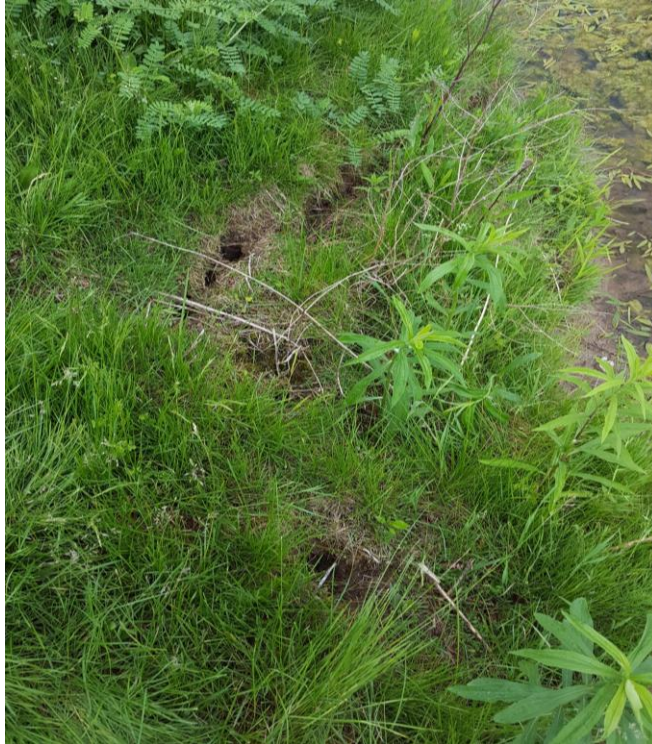
Mowing up to the edge of the pond creates a source of phosphorus via grass clippings that can lead increased aquatic vegetation and algae growth. Also, in this case, mowing up to the edge of the pond has caused slumping of the banks in some locations (see **figure 1**). When the soil from the banks slumps into the pond, it creates another source of nutrients and sediments. Lastly, mowing grass on pond banks creates a desirable habitat for waterfowl. Most waterfowl, especially Canada Geese, tend to nest near ponds that have easy water access, and good visibility of the surrounding banks. Droppings from waterfowl can be very nutrient rich and can be another continual source of pollutants to a pond throughout the spring and summer. Creating a buffer around the pond is a good way to drastically cut down on the incoming phosphorus and other nutrients from these three sources.

Figure 1- One example of an area of slumping pond bank that is likely due to the weight of the mower on the edge of the saturated bank.

There are a number of other areas that can be improved upon in order to make this stormwater pond more aesthetically appealing. Currently, grassed areas are being mowed up to the edge of the pond. I would suggest that a buffer is created between the edge of the pond and the mowed grass areas. These buffers can be created simply by not mowing closer than 5-10 feet from the edge of the pond and allowing tall grasses and vegetation to grow and fill in. Buffers can also be more complex, landscaped areas. From an aesthetics stand point, a landscaped buffer containing different wildflowers, shrubs, and bushes are more desirable, however, they are also more expensive to install and maintain.

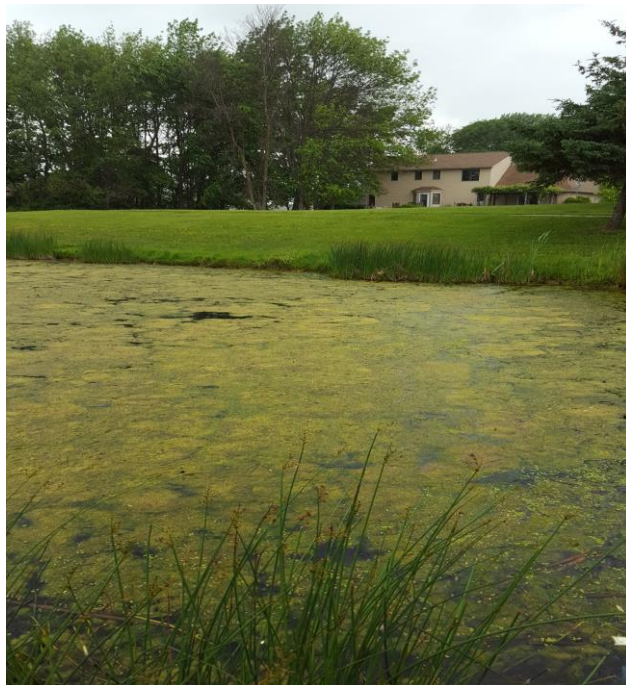
The eastern corner of the pond was mostly covered in a type of surface dwelling plant known as duckweed, which typically indicates high levels of phosphorus (see **figure 2**). It is likely that duckweed is only present in that corner of the pond due to a lack of flow. There are no storm sewer inlets in that corner of the pond to provide flow to the pond's outlet. An aerator or fountain in that corner of the pond could help to provide sufficient flow to push the free floating plant out of the pond's outlet. In all of these cases, bottom raking, seining and surface skimming are acceptable and effective practices for immediate aquatic vegetation removal.

Figure 2- Eastern end of the stormwater pond that has a high duckweed coverage on the surface of the water, which is likely due to the lake of flow in this area.

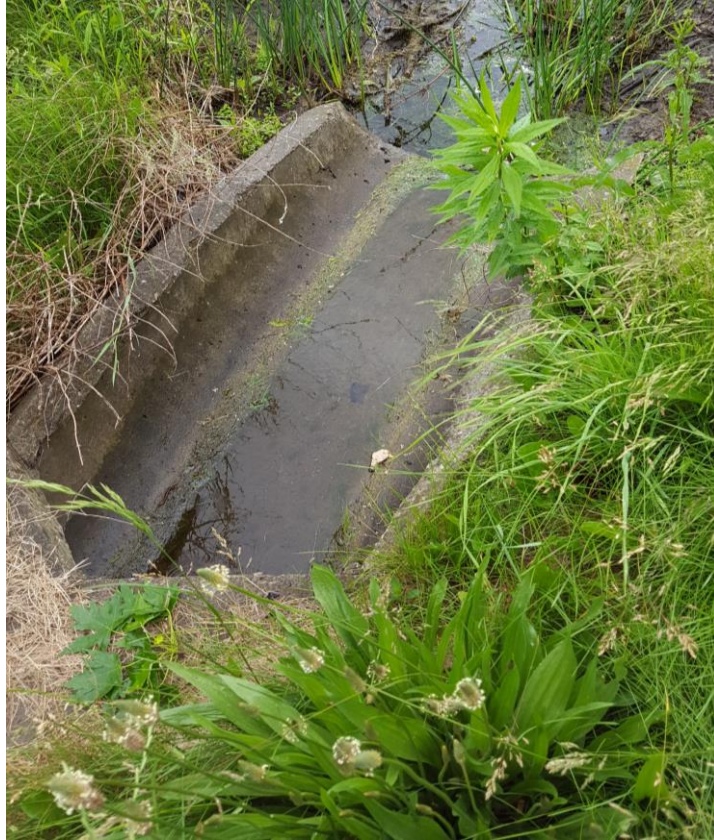
- ❖ **Clean lined channels and drainage areas-** During the visit, grass clippings were found in a concrete channel that drains directly into the pond (see **figure 3**). These channels should be cleaned after mowing to prevent grass clippings from entering the pond. If possible, I would also suggest stopping mowing up to the edge of the concrete channel.

Figure 3- outfall that is conveying grass clippings into the pond from the lined concrete channel above.

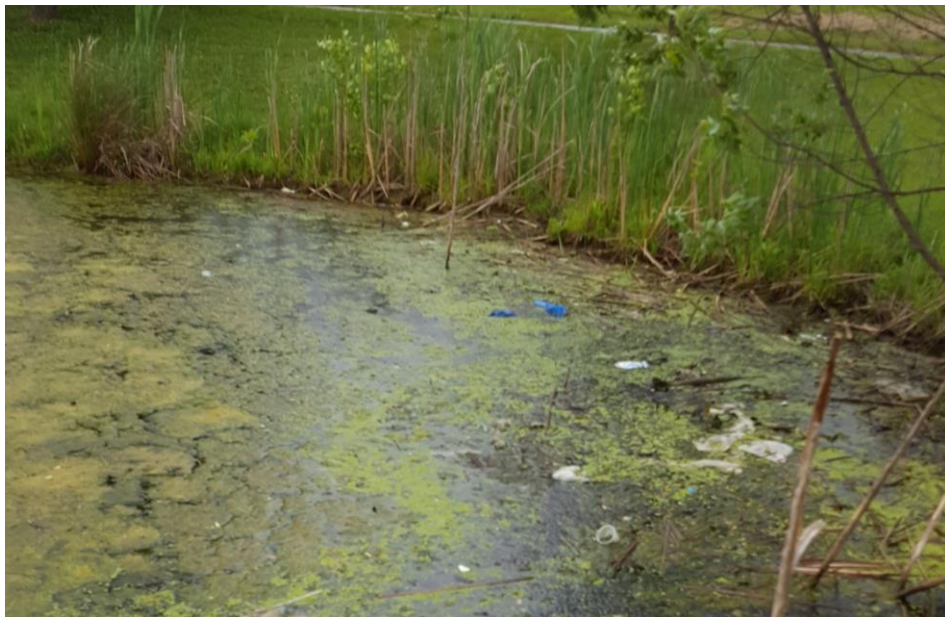
- ❖ **Clean up garbage in and around pond-** There was garbage present in a few locations around the pond (see **figure 4**). Periodically picking up the garbage from the pond is an easy and effective way to improve the aesthetics of the pond.

Figure 4-location in the pond where garbage and waste has accumulated.

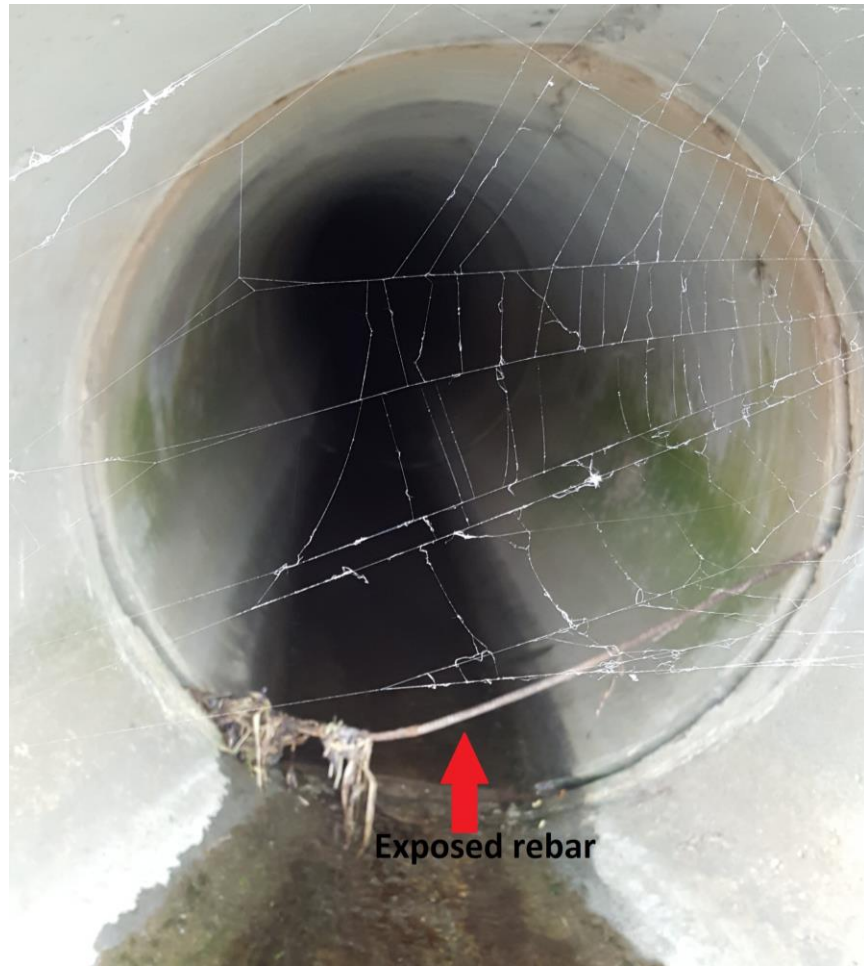
Figure 5- Rebar is exposed in the southwestern outfall that drains into the pond.
